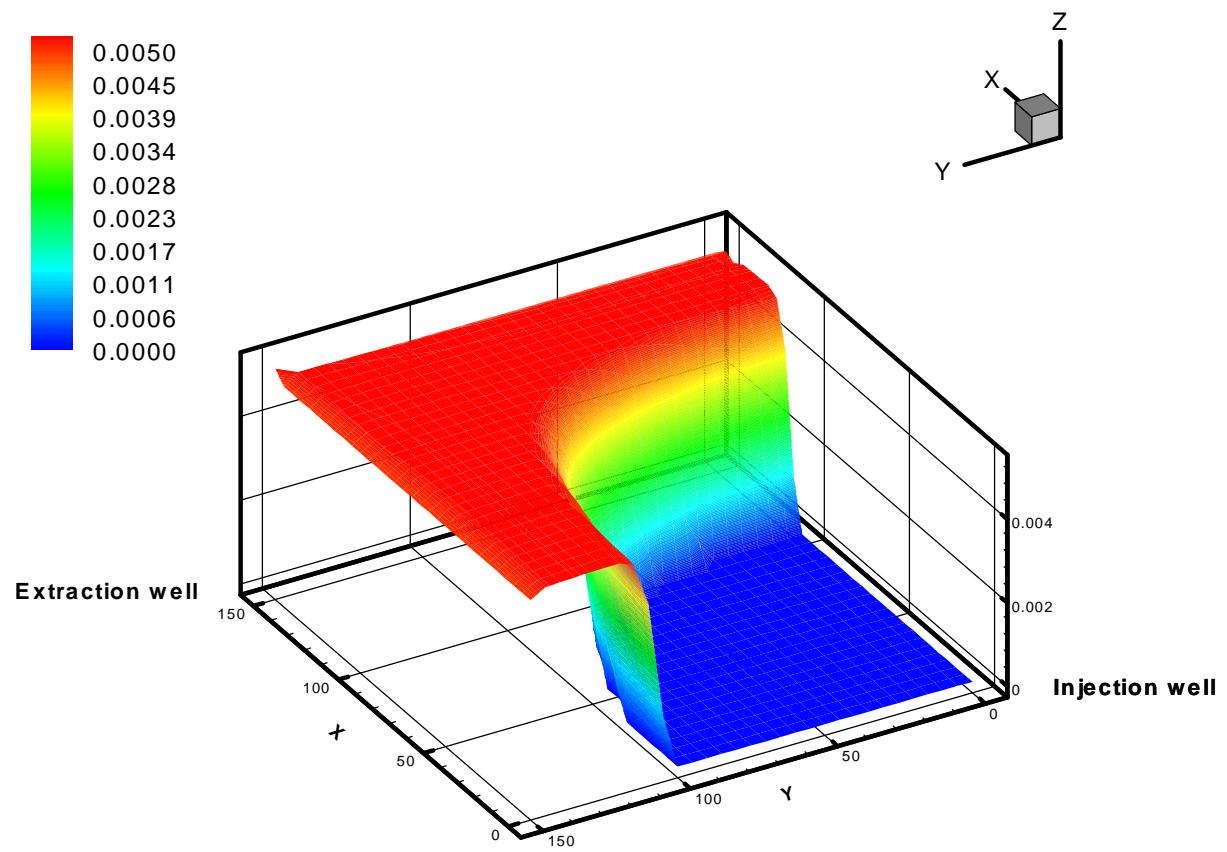
Figure 6.6. Volume Fraction of Chrysocolla after 0.25 years of Copper Leaching.
